## Performance of composite unprotected steel Beam-deck floor exposed to high temperature (fire flame)

Assist. Prof. Dr. Amer Farouk Izzet  
Ammar Abdulsattar Abdulmajeed  
Department of Civil Engineering, University of Baghdad  
Al-Jaderia , Baghdad, Republic of Iraq  
[amer.f@coeng.uobaghdad.edu.iq](mailto:amer.f@coeng.uobaghdad.edu.iq)  
[ammar.a@uomustansiriyah.edu.iq](mailto:ammar.a@uomustansiriyah.edu.iq)

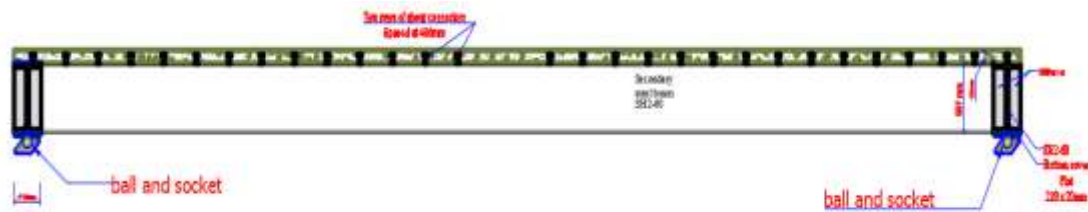
Fig. 1 The chosen beams cross-section of full scale designed composite SB-RC Deck floor

( a ) Specimen of one secondary beams (Top View )

( b ) Specimen of one secondary beams (Side View )

A composite SB-RC deck floor of 12 m and 14.4 m span length and width, respectively, simply supported boundary condition at each edge corner was selected and designed. The structural analysis depends on live load application according to ASCE, requiring nine secondary steel beams of SH2-60 (Russian rolled sections) spaced at 1.8 m and welded to two main beams of HS3-70 with an additional bottom steel plate and 120 mm reinforced concrete deck floor. One of the internal secondary steel beams was selected with a portion of reinforced concrete deck floor specified by a half beam spacing center on all sides. The designed steel beam, concrete deck, stiffeners, and shear connectors are illustrated in **Fig. 1**.

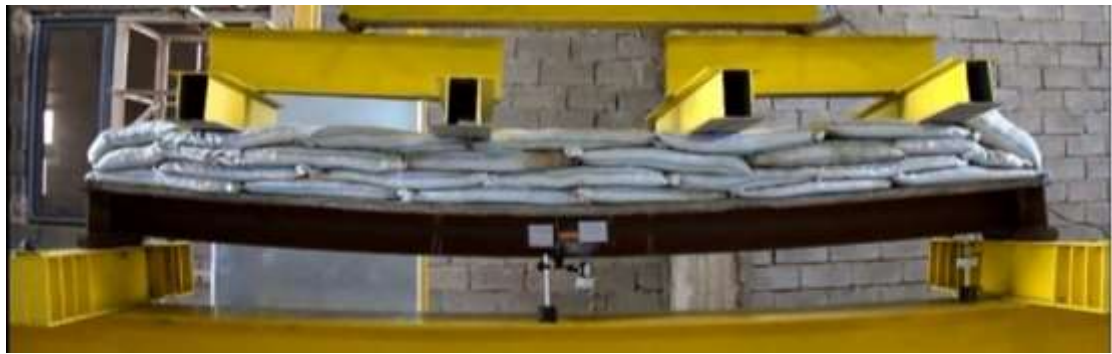
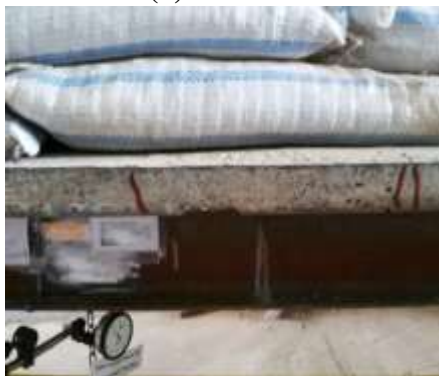
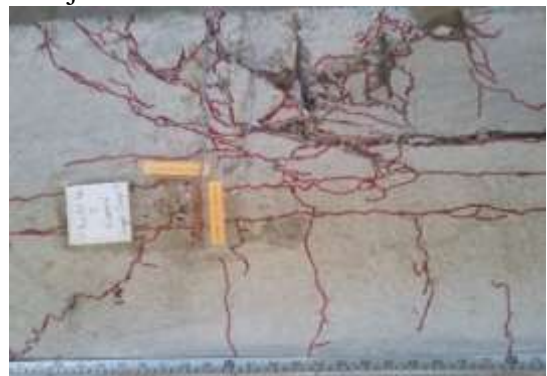
**Plate 2.** Failure of reference composite SB-RC deck floor (SB-RC<sub>R</sub>)

(a) Excessive deflection of SB-RC<sub>R</sub> just before failure

(b) Flexural cracks side view

(c) Flexural cracks top view

Failure of reference composite SB-RC deck floor (*SB-RC<sub>R</sub>*) passed through different stages, started with the apparent mid-span deflection **Plate 2-a**. Due to the uniform equivalent applied load, led to the development of cracks on both concrete deck sides which can only be observed **Plate 2-b**, even when the top concrete strain reached the nominal ultimate value of 3000 microstrain, the propagation of cracks or crashing could not be specified. With increasing load, the bottom steel flange reached yield stress, thereafter, excessive deflection was measured and the composite SB-RC deck floor could not resist any further applied load. Top concrete cracks and damages were observed after removing the uniform equivalent applied load **Plate 2-c**.

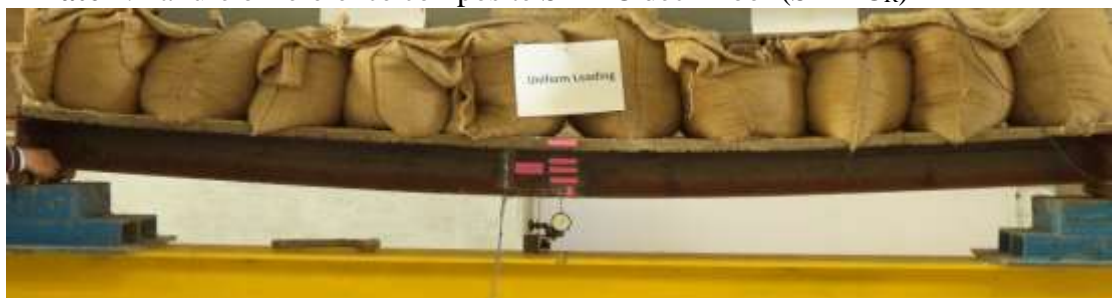
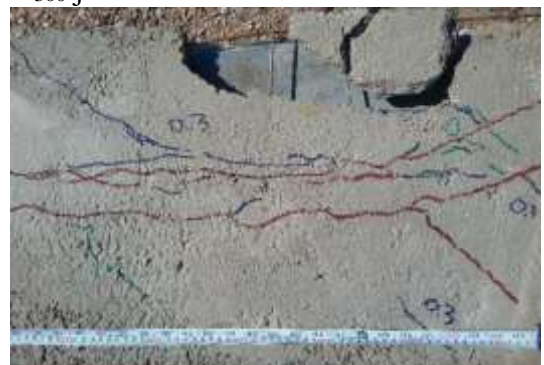
**Plate. 3** Failure of burned composite SB-RC deck floor SB-RC<sub>300</sub>) after loading stage

(a) Excessive deflection of SB-RC<sub>300</sub> just before failure

(b) Flexural cracks top view

(c) Lateral crushing of concrete deck

**Plates 3** through **5** show the failure of burned composite SB-RC deck floors, showcasing the same behavior as that of *SB-RC<sub>R</sub>*, but these specimens were pre-damaged as a

result of the burning stage. Obviously, as the burning temperature increases, the damage of concrete as well as steel beam increases. This could have affected the ultimate load resistance and the failure of these specimens. Despite the structural

composition of specimens and the applied load on all topping concrete deck, longitudinal top cracks were detected, followed by lateral crushing of concrete deck as in *SB-RC<sub>300</sub>* specimen (Plate 3-c).

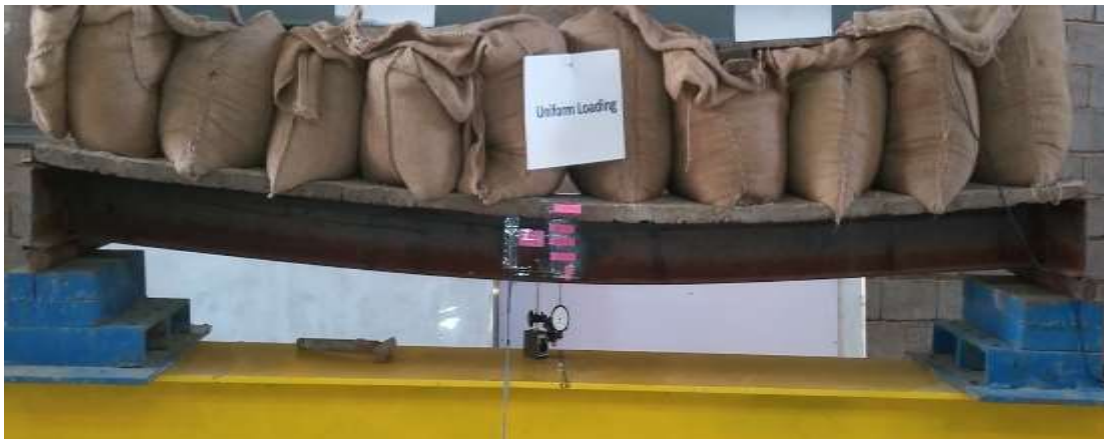
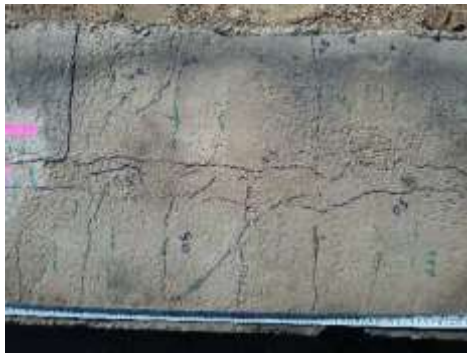
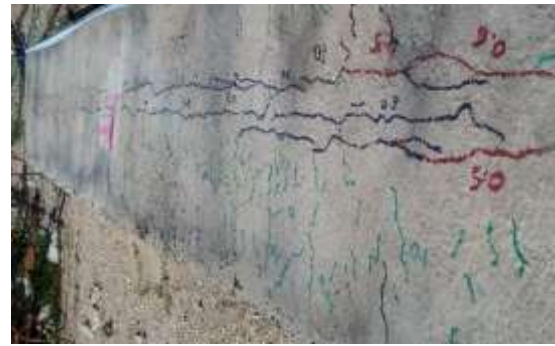
**Plate 4.** Failure of burned composite SB-RC deck floor (SB-RC<sub>500</sub>) after loading stage

(a) Excessive deflection of SB-RC<sub>500</sub> just before failure

(b) Flexural cracks top view

(c) Longitudinal concrete deck cracks

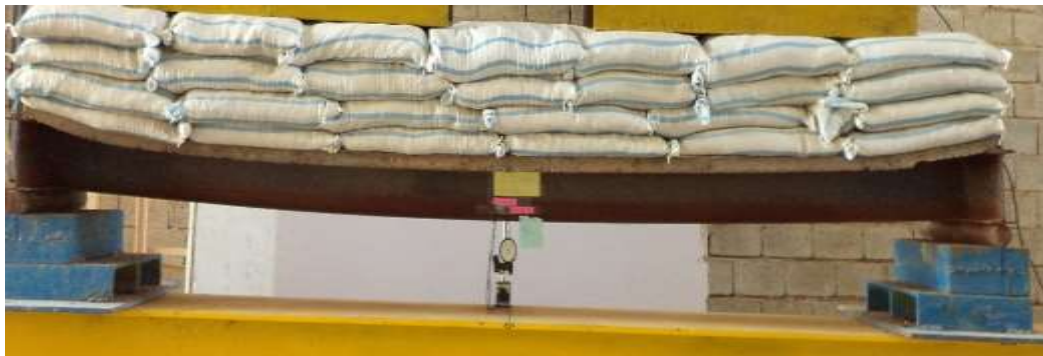
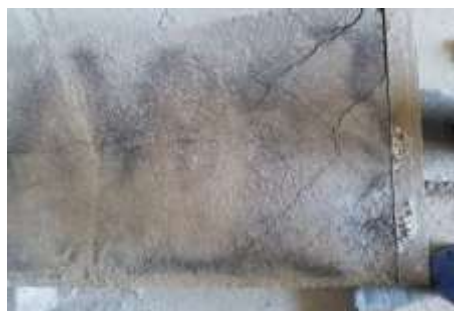
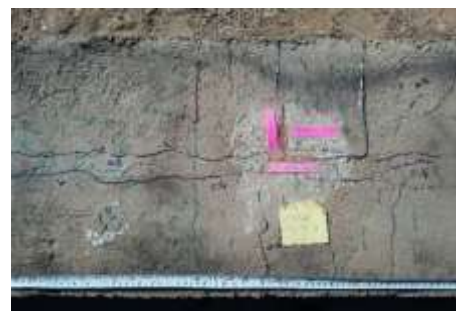
**Plate 5.** Failure of burned composite SB-RC deck floor (SB-RC<sub>700</sub>) after loading stage

(a) Excessive deflection of SB-RC<sub>700</sub> just before failure

(b) Flexural cracks top view

(c) Lateral crushing of concrete deck
